ALDON TECHNOLOGIES SERVICES PTE LTD

Y_2O_3 Plasma Coating

What is Plasma Spray Coating

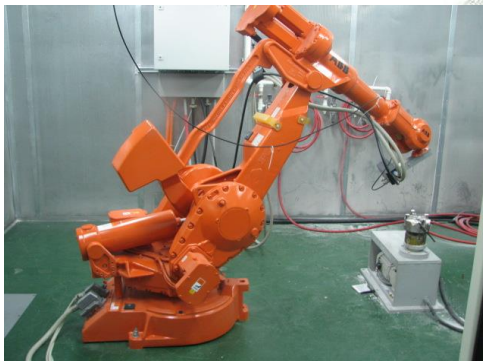
Automated Robotic Arm

- Capable of spraying Aluminium, Tungsten Carbide, Al₂O₃, Y₂O₃ etc coating material. Working dimensions 2.0m (L) x 1.5m (W) for automated process.
- Automated robotic arm spraying to ensure consistent and reliable process.

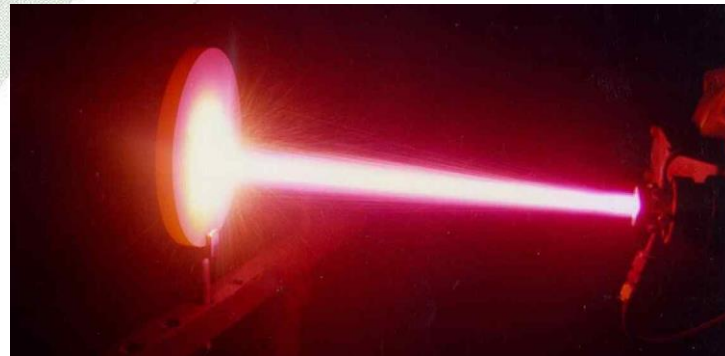
Plasma Coating Spraying Illustration

Plasma Spray Coating – A process in which a heat source transforms metallic or non-metallic materials into a spray of molten or semi-molten particles that are deposited onto metal substrates.

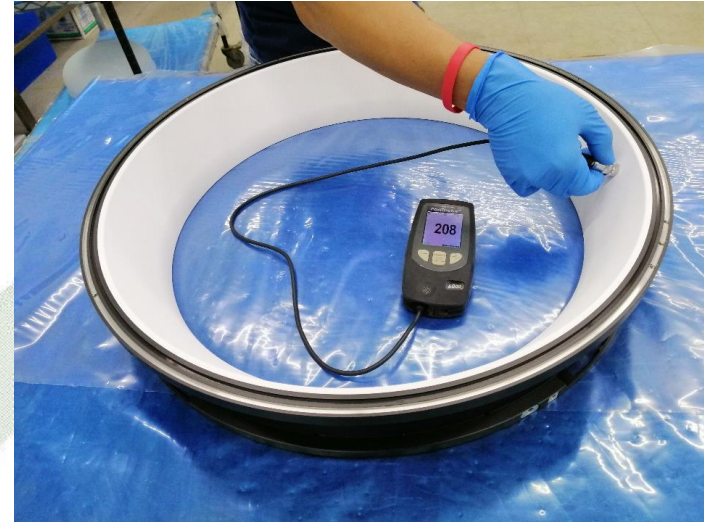
QC Coating Thickness
Measurement

- Specs ensures proper coverage of surface; too thick will result in easy peeling.
- Thickness requirement monitoring in-placed during coating and outgoing QA inspection.
- Custom Spray available according to Customer Requirements

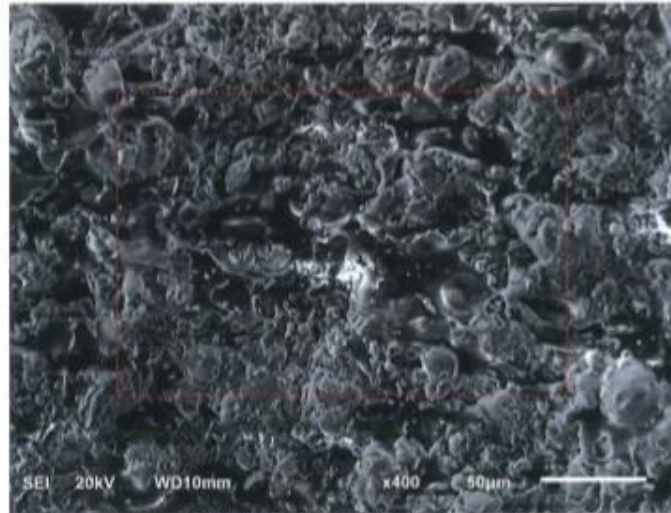
Figure 2a: Typical SEM image of test coupon '5', 400X

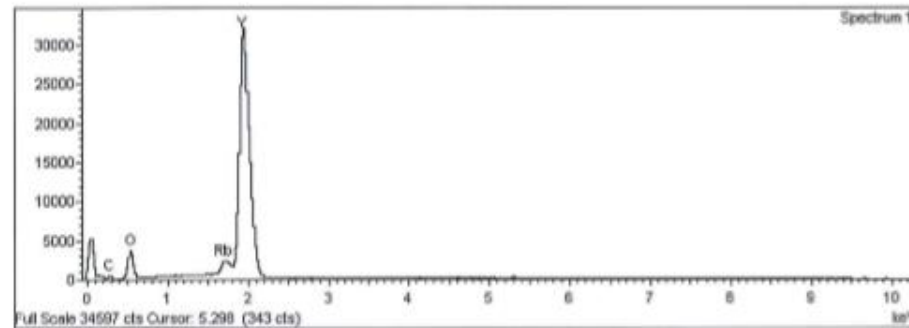
Figure 2b: Typical EDX spectrum of test coupon '5'

Table 2: Elements percentage breakdown for test coupon '5'

Element	Y	O ^a	Rb
Wt %	72.6	25.8	1.6

- Higher grade and superior quality of material is used. Our coating EDX confirmed there is no contaminants within the powder material and coating processes.
- Good plasma resistance coating can improve the part lifetime. Some customers feedback that their part lifetime has been increased 2x.
- Higher bonding strength improve coating quality with less peeling problem. We have some
- Cases of peeling issue which is-related to part handling by customer.
- Localization of services improve customer response time.

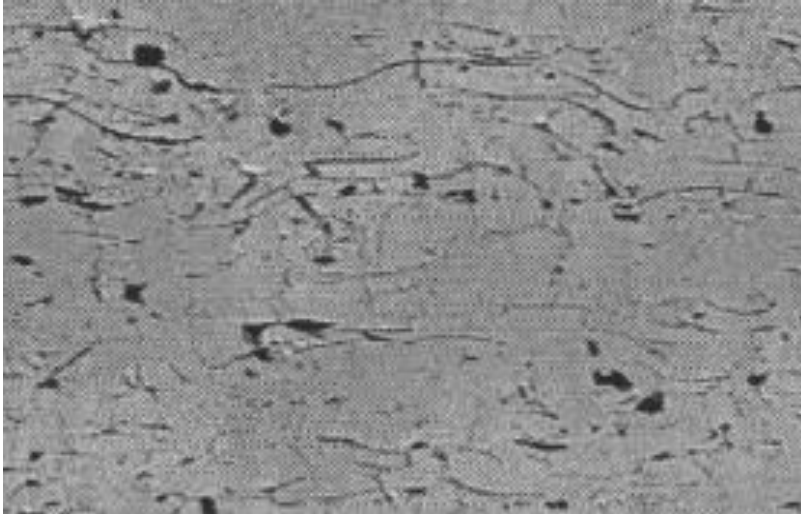
Porosity good = with small gaps

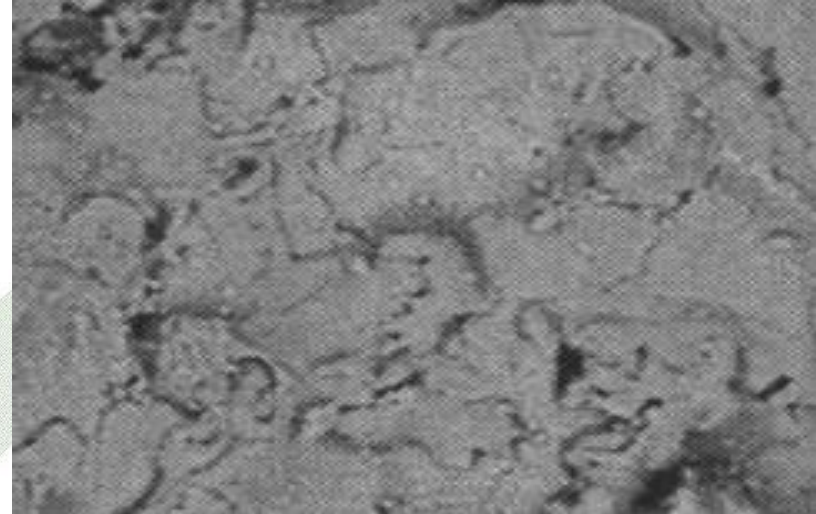
Surface melt good = even surface melts

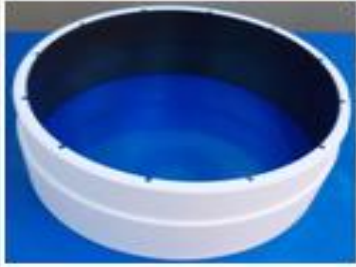
2	0021-34196	Cathode Liner	Al Partially Coated Y_2O_3

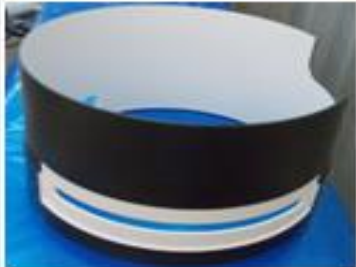
3	0040-99548	Chamber Liner Left	Al Partially Coated Y_2O_3

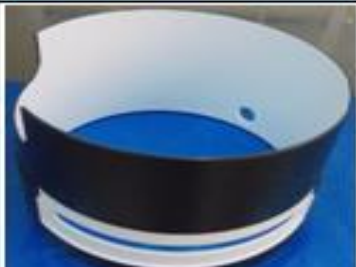
4	0040-99549	Chamber Liner Right	Al Partially Coated Y_2O_3

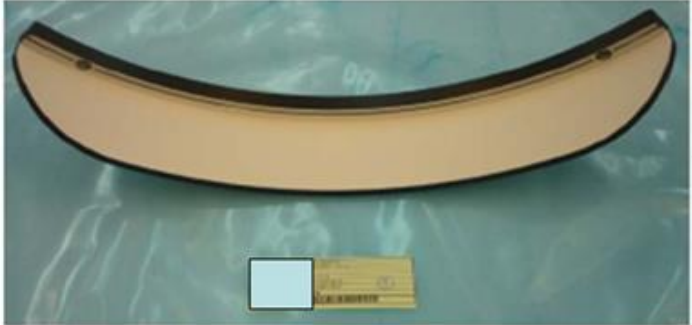
ATS A Company of Aldon Group				Final Inspection Report Anodize & Y2O3-Coating				Ref No: DO-113509-10	
Part No.		3D10-101152-12		Serial No.		42016UR-15212		Customer	
Name		SHUTTER						Module	
								TEL SCCM	
						Date In (yyyymmdd)		20110725	
								Date Out (yyyymmdd)	
								20110909	
Check Point	Anodizing Thk. (µm)	Ra on anodize surface (µm)	Y2O3 Thk. (µm)	Pictures & illustrations:

Spec	55 ± 5 µm	0.5-3.0 µm	150 ± 30 µm						
1									
2									
3									
4									
5									
6									
7									
8									
9									
10									
11									
12									
13									
14									
15									
Min.									
Max.									
Avg.									
Result									
Y2O3 Surface Roughness (Ra 3.5 - 5.5 µm)				Notes: Y2O3 Surface roughness measured on test coupon. the part is re-anodized and re-coated.					
Surface Particle ≤5 cnt/cm² @ ≥0.3µm									
Insp. Result									
ACCEPT									
Inspected by				Visual Inspection
